NASA Technical Memorandum 81352

THE EFFECT OF THERMAL STRESSES ON THE INTEGRITY  
OF THREE BUILT-UP AIRCRAFT STRUCTURES

Jerald M. Jenkins

November 1980

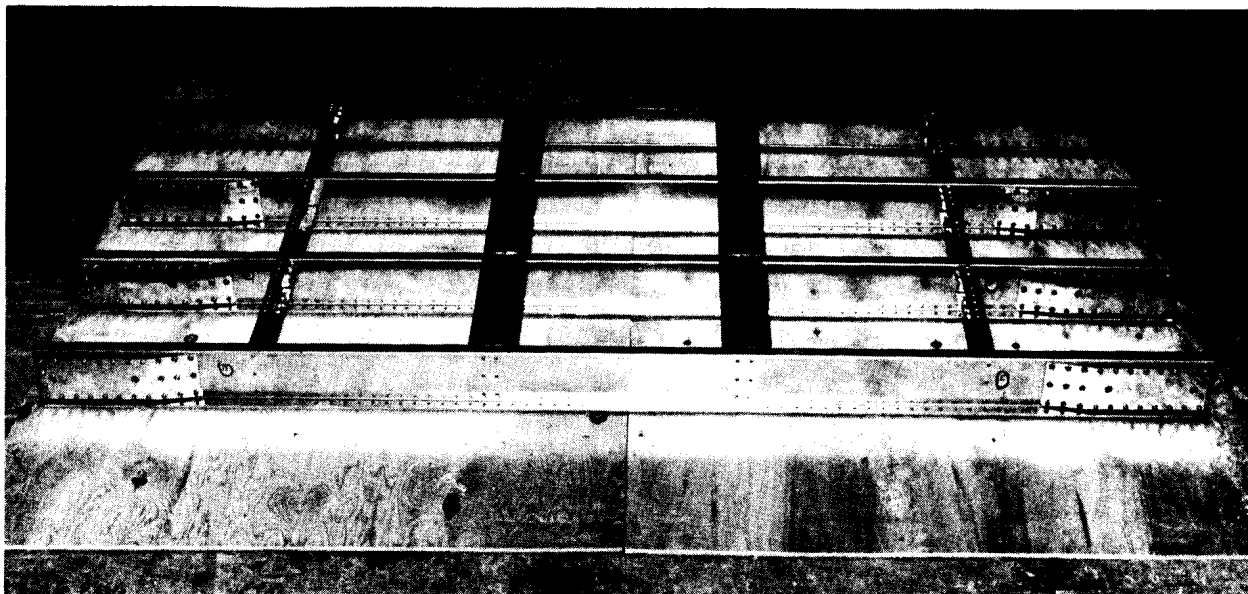
Figure 3. Stainless steel Z-frame structure identified as Frame B.

Three distinct fuselage frame (ring) concepts were conceived after the completion of the study of reference 14. A built-up test specimen of each of the three concepts was fabricated to represent a portion of the bottom side of the blended wing-body structure. The specimens included the load carrying skin with integral frame stiffeners. The three specimens are shown as a group in figure 1. The frame structure shown in the background of figure 1 (and in more detail in figure 2) is a truss type frame structure constructed of titanium (6Al-4V). This specimen will be referred to hereafter as Frame A. The middle frame structure, shown in figure 1, is fabricated of stainless steel (Type 301) with the frame formed in a Z-shape. This frame specimen will be referred to as Frame B and it is shown in more detail in figure 3. The frame structure in the foreground of figure 1 has a Z-shaped section constructed of titanium (6Al-4V). This frame specimen has the skin fastened to it which is made of Lockalloy (Be-38Al). The skin is interchangeable between the three frame concepts. The frame concept in the foreground of figure 1 will be designated Frame C and a more detailed picture is shown in figure 4.

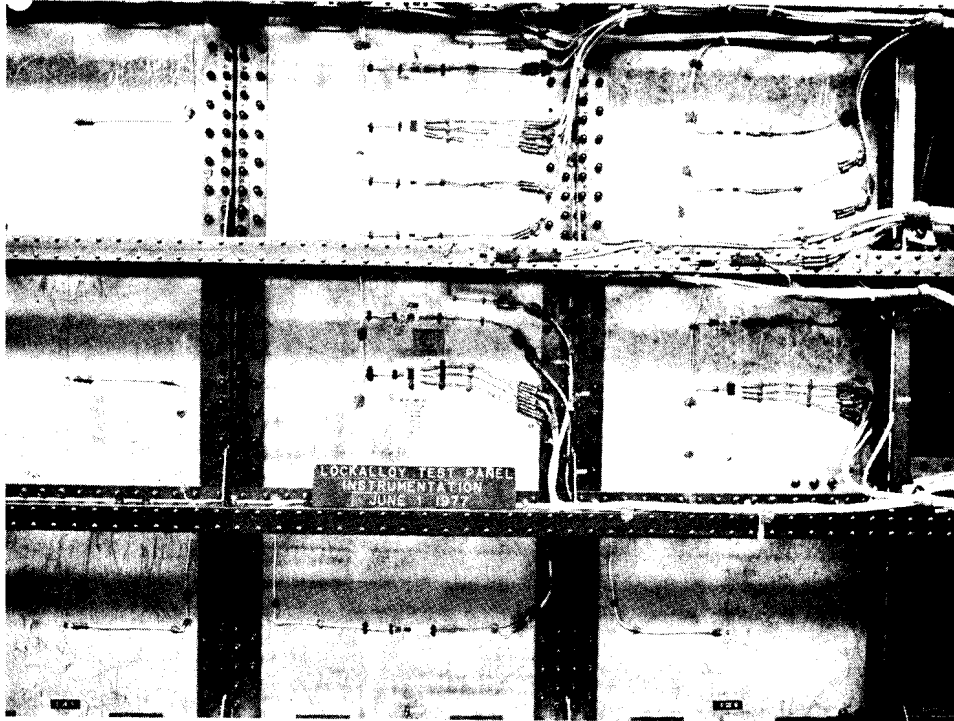
Figure 9. Overall view of the strain gages and thermocouples.

A photograph showing part of the instrumentation on the skins is presented in figure 9 for Frame A. A more detailed photograph
